# Survey of the experiences in particular with the prototype of the CWD 2000 windmill at the Technical University Eindhoven from May 1983 until December 1985

Survey of the experiences in  
particular with the prototype of the  
CWD 2000 windmill at the  
Technical University Eindhoven  
From May 1983 until December 1985

Ad v.d. NAT

R 810 D

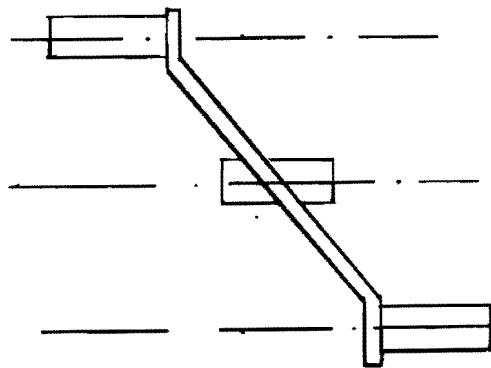
After erection it appears that the windmill has a bad starting behaviour.

The windmill starts at 4 m/sec but it should start at 2.5 m/sec. The cause is probably friction in the wooden bearings of the rocker arm, pump rod and crank rod.

The cause of the friction is the incorrect manufacture of the rocker arm.

The axes of the rocker arm are not parallel.

The axle lines are not parallel

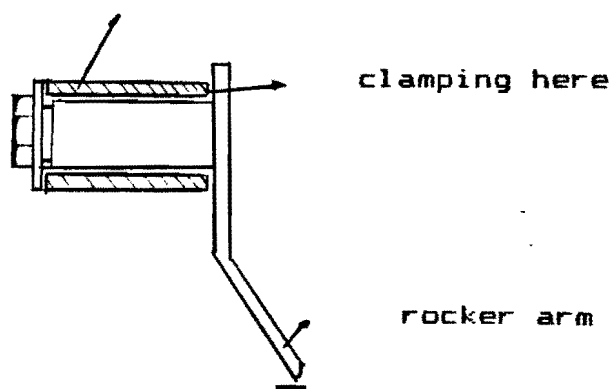
Also the shaft taps are too short so the pump rod is clamping on the rocker arm.

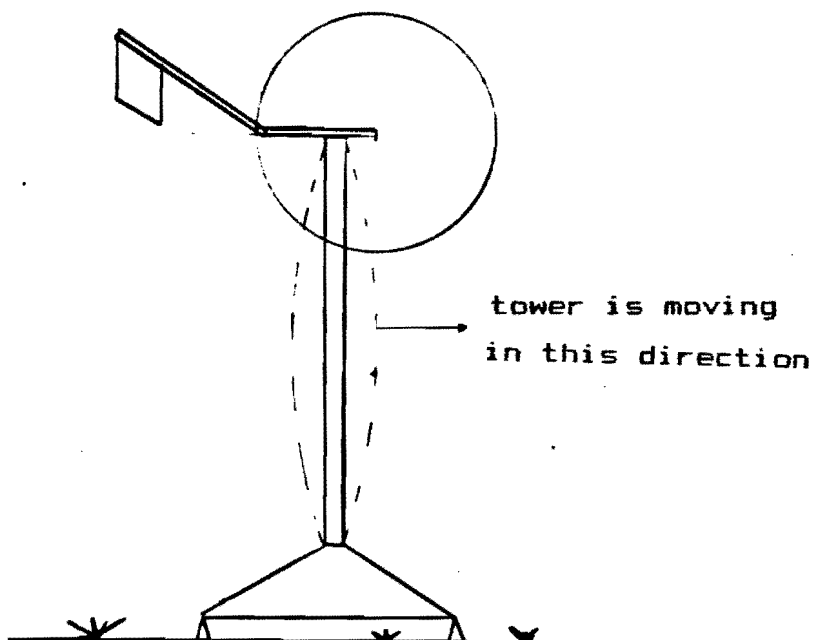
When the windmill is running the tower is bending. For direction, of move; see drawing.

The starting behaviour is ok, now the windmill is starting at  $\pm 2,5$  m/sec. The tower was made more stiff now (see remark date 1983.05.11)

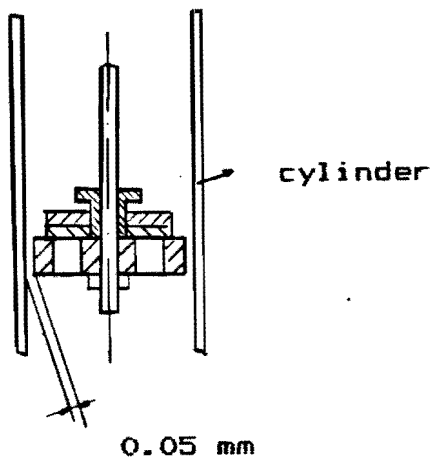
Experiment with piston without a leather cup.

The piston is made of synthetic material (teflon) the cylinder is made of brass. There is a slit between the piston and the cylinder which has the same function as the starting hole in the usual piston.

Water level 2,00 m.  
 Reading water flow meter 50 m<sup>3</sup>.  
 Pressure height 4 meter.  
 Stroke 50 mm.  
 However during testing of the pump it appeared that the piston stuck in the cylinder. The cause was an unroundness of the brass cylinder and/or probably the sucking up of water of the teflon piston.  
 Teflon can suck up water up to 5%.

The synthetic piston was made a little smaller so the sticking of the piston is over now. However, the slit between piston and cylinder is too large now.  
 The pump delivers too less water and the windmill is starting too early at  $\pm$  1,5 m/sec. It was decided to use the piston with a leather cup running in the brass cylinder.  
 Pressure height 4 meter.  
 Water level 1 meter.  
 Reading water flow meter 60 m<sup>3</sup>.  
 Stroke 50 mm.

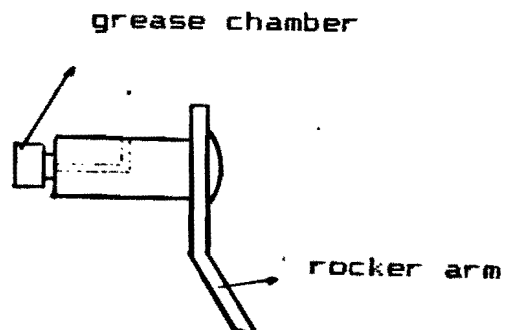
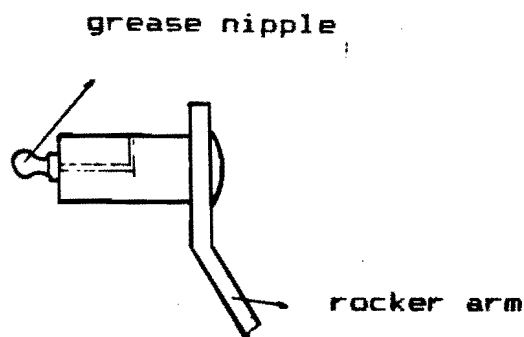
After dismounting of the windmill in order to paint it the following faults appeared.

- a. The wooden bearings were complete worn out.  
 The crank pins of the rocker arm are also worn out.  
 The cause being defective lubrication by ineffective grease cups.
- b. The rotor shaft bearings are worn out.  
 The cause being defective lubrication by no grease in the bearing house.

We manufactured new crank pins and made another lubrication system.

The grease cups were replaced by grease nipples.  
See drawing

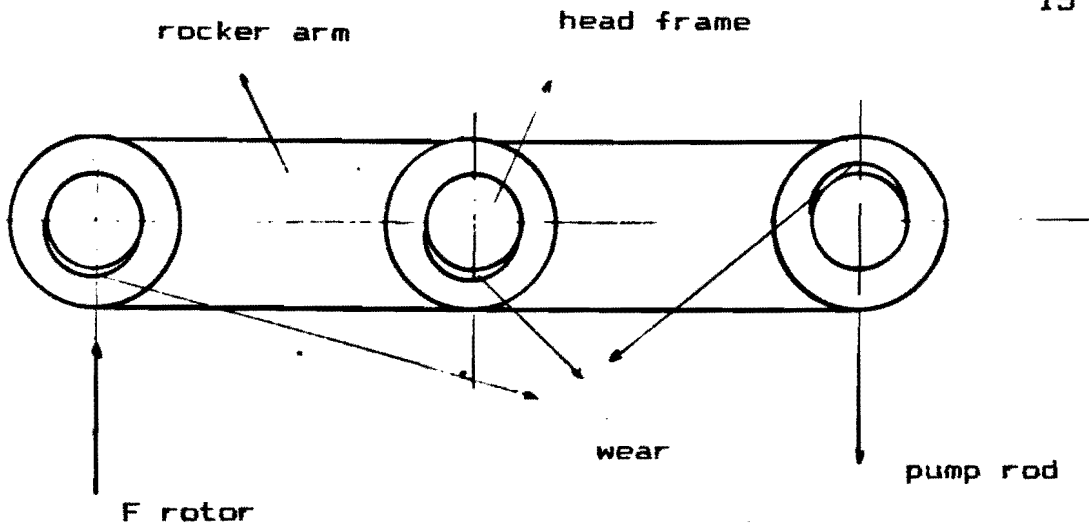
- a. The wear of the rocker arm.  
See drawing

- a. Manufacturing of new crank pins for rocker arm and head frame.
- b. Manufacturing of new wooden bearings for rocker arm and pump rod.
- c. Manufacturing of new rotor shaft.
- d. Removing of old crank pins from rocker arm head frame.

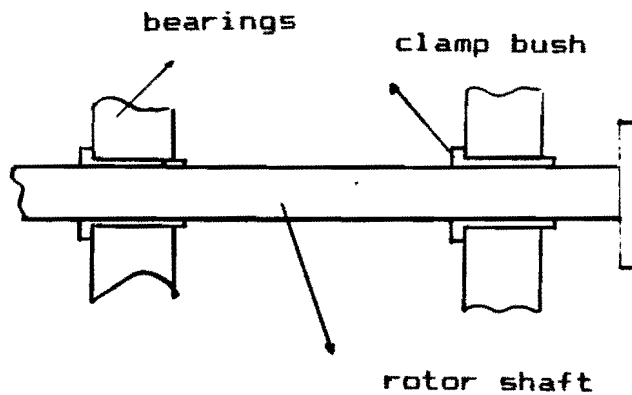
- b. The wear of the rotor shaft.  
See drawing.

Note: The bearing house had not been filled with grease.

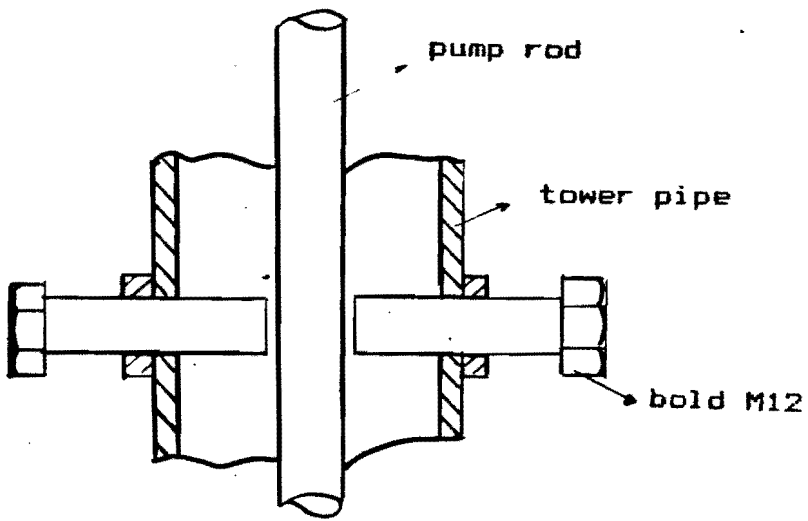
- c. The ball bearing of the exenter had not been filled with grease.  
 But this bearing has not been damaged.
- d. The painting of the tower is still ok.  
 We painted the windmill for reasons of estetics.
- e. There was no wear on the pump rod guide.  
 See drawing.

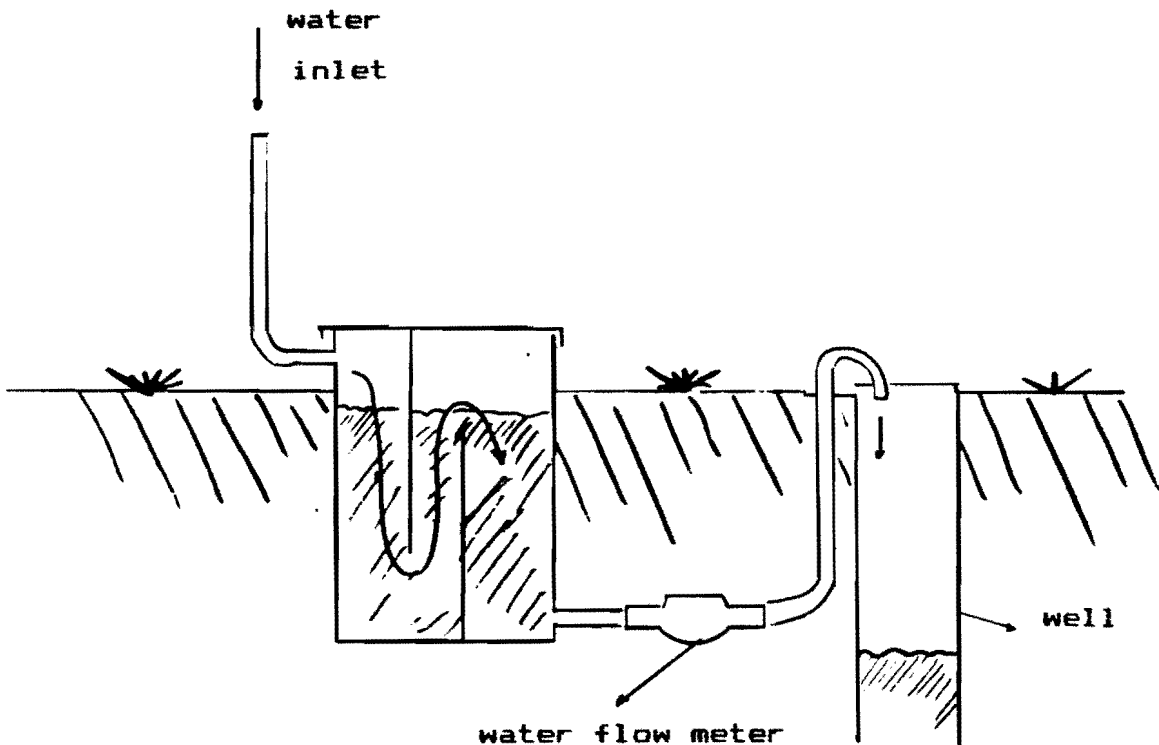
The windmill stows the water to the top of the tower where it is running over.  
Cause being probably the resistance of the water flow meter.  
The wooden bearings are running stuck.  
Cause being swell of the bearings by the water from the top of the tower. Windmill starts now at 4,5 m/sec.  
Pressure height 5,5 meter.  
Water level 1,80 meter.  
Reading water flow meter 2179 m<sup>3</sup>.  
Stroke 50 mm.

A collecting vessel has been installed in the return line.  
The water flow meter in the pressure line has been removed.

This reduced the resistance of the pressure line.  
See drawing.

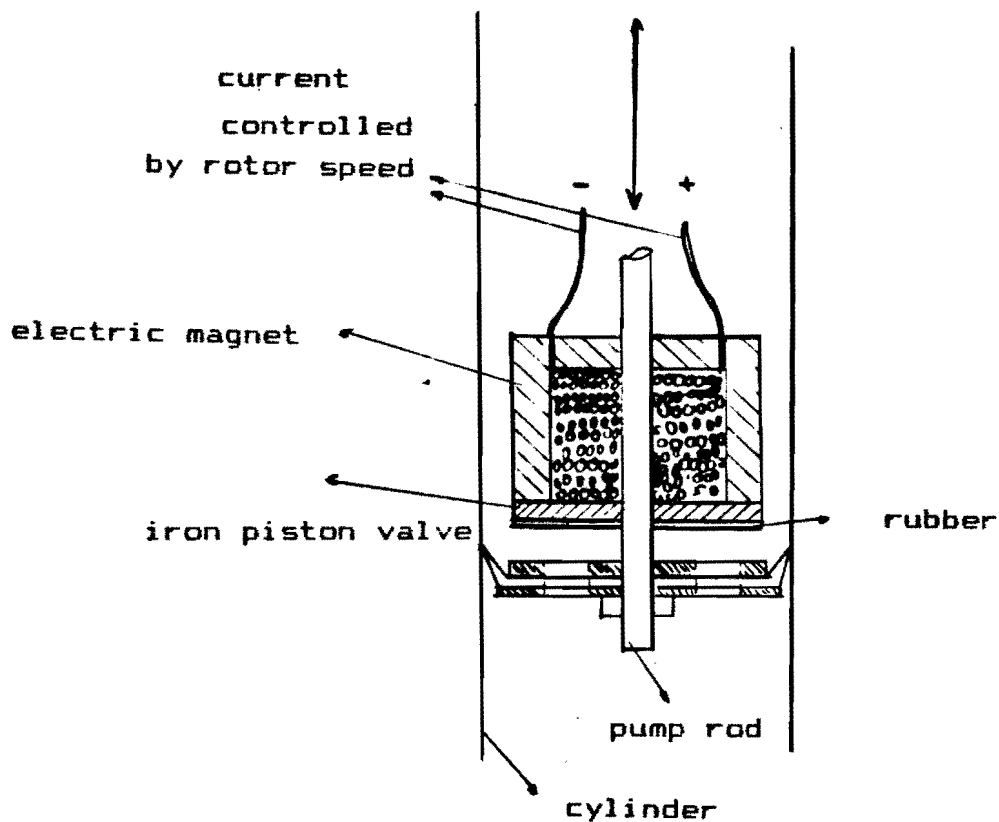
The electric controlled piston valve

A starting behaviour equal to the normal conditions was found. It was decided to do a test with an electric controlled piston valve to investigate if it would be possible to reduce the starting wind speed.

The electric magnet keeps the piston valve open until the rpm counter gives the sign to loose the valve. Then the windmill starts to deliver water. The starting wind speed of the windmill is  $\pm 0,5$  a  $1$  m/sec. Pressure height  $3,5$  meter. Water level  $5,5$  m<sup>3</sup> below ground level. Reading water flow meter  $1428$  m<sup>3</sup>.
