SURVEY OF THE EXPERIENCES ON THE TESTFIELD
AT THE EINDHOVEN UNIVERSITY OF TECHNOLOGY
IN PARTICULAR FOR THE WEU 1-3 WINDMILL
from April 1983 until May 1985

Ad v.d. Nat

July 1985

R-742-D

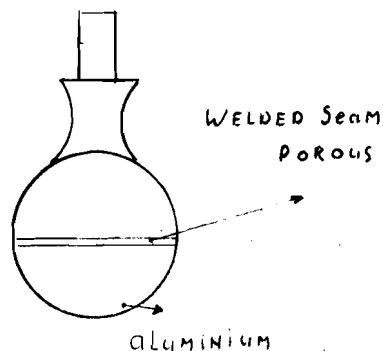
Fig. 2

25.04.1983 The pump is mounted and the windmill is running, however the delivery air chamber is leaking, the cause being a porous welded seam.

A spare delivery air chamber is installed, this one is o.k. The counter piston is leaking a little: about 10 cc per stroke. The pump foundation is too light so when the windmill is running it is moving up and down. The solution for this problem is to make the foundation heavier by adding 50 kg of concrete.

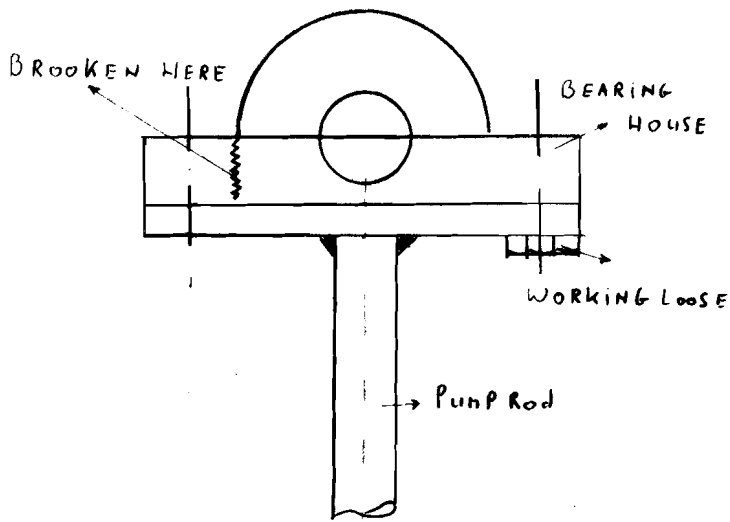
Fig. 5

06.05.1983 The crankshaft bearing housing is broken. The cause is probably work-
ing loose of a nut due to a soft spring washer.

A new bearing housing is mounted, using a good quality spring washer.

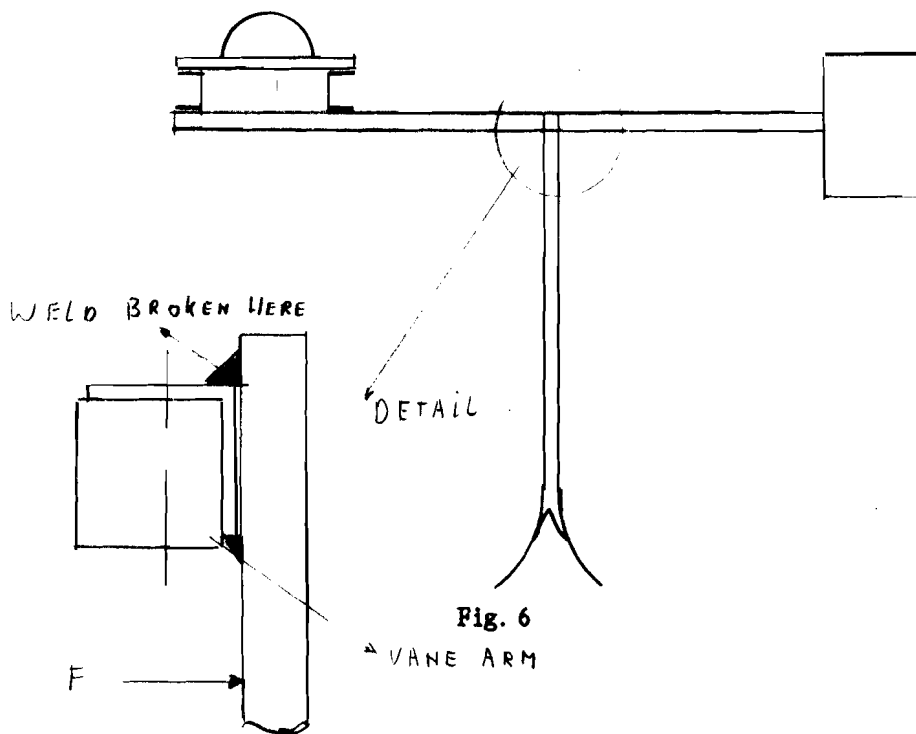
Fig. 6

19.05.1983 The furling system is broken, probably during the storm on 12.5.1983..
The wind gives too strong a force on the connection of the furling mechanism to the side vane arm.

- 02.06.1983 The furling system is repaired and mounted.
The suction and delivery air chamber are painted on the inside with coal tar to be sure that they are tight. They are not leaking anymore.

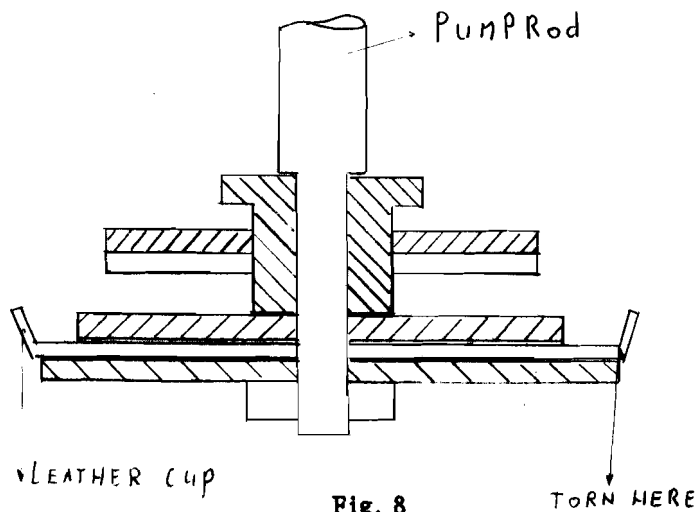
21.09.1983 The pump delivers no water. After dismounting the pump it appears that the leather cup is torn away from the piston.
Probably it is torn away by too high pressure by a blocked waterflowmeter.

A new cup is made and the pump is mounted again. The pump is working again.

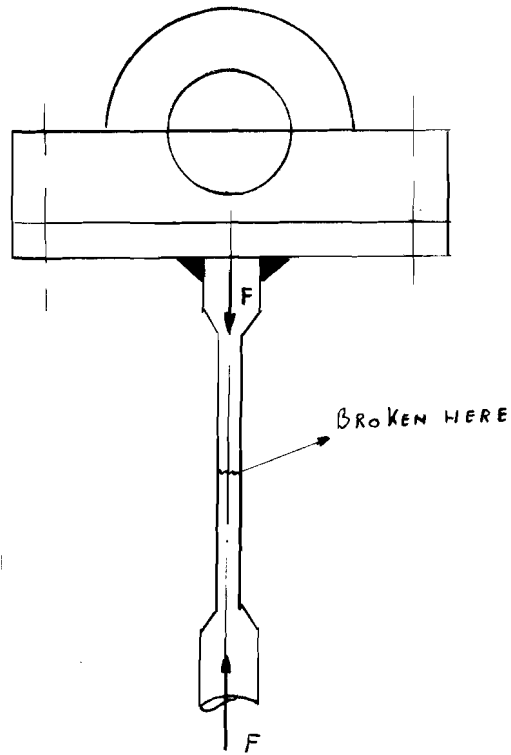
Fig. 9

12.10.1983 The pumprod is broken below the crankshaft bearing housing.
The cause is high pressure forces in the pumprod.
The pumprod is buckled.

A new pumprod of the same size as the old one is made.

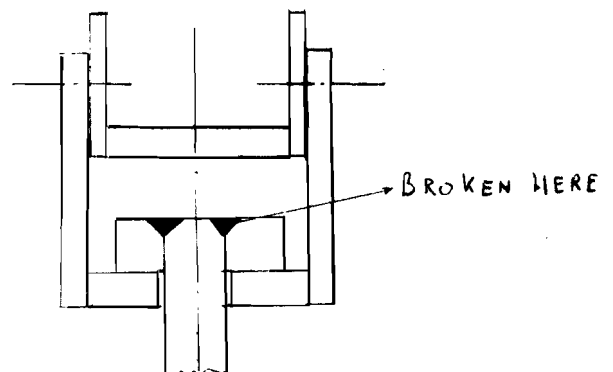
Fig. 12

06.01.1984 The swivel point of the pumprod has broken. The cause is too high a pumprod force.

The cause of the high forces in the pumprod is among others a play of ± 5 mm in the swivel point, so there is a shock load on the pumprod.

Swivel point is repaired and mounted again.

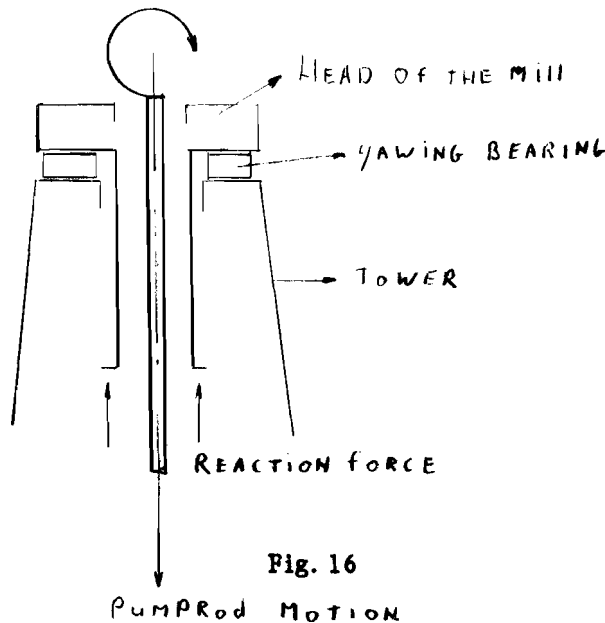
Fig. 16

19.01.1984 During a heavy storm, it appears that the head of the windmill is lifted up by the pumprod ± 5 cm just before it turns out of the wind, which causes high forces on vanes and rotor.

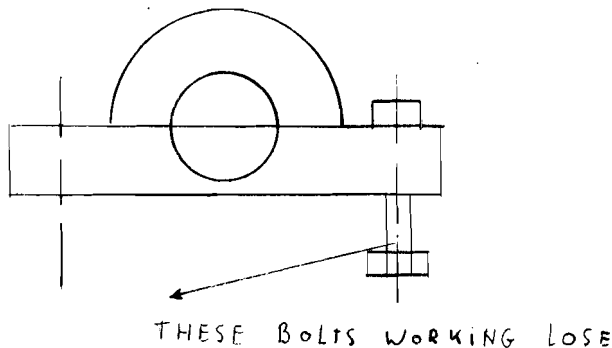
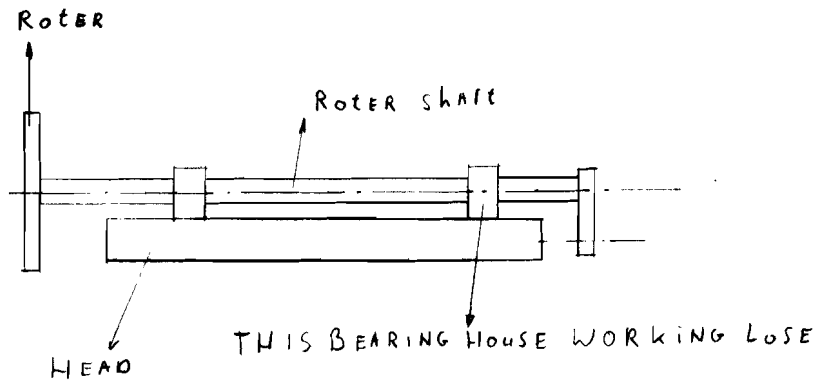
03.02.1984 Of the main shaft bearing housing at the back of the head frame the bolts are running loose. The cause is probably soft spring washers. The pumprod has broken at the flattened part.

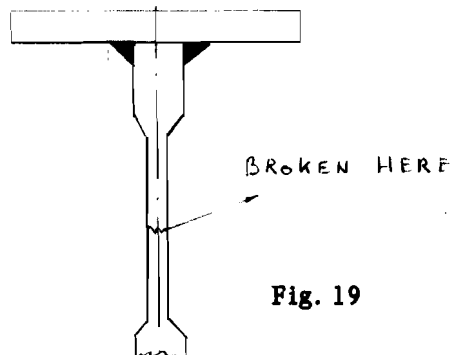
Fig. 19

01.03.1984 The pumprod has broken again at the flattened part.

It is decided to make this part of the pumprod stronger.
The 1" flattened tube is replaced by a $\phi 16 \text{ mm}$ rod.

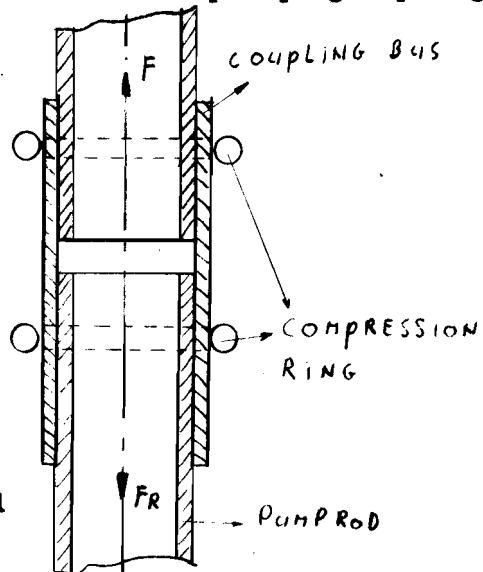
Fig. 21

08.03.1984 The clamp couplings of the pumprod can not take the maximum pump-rod force.

At maximum RPM of the rotor one of the clamp couplings is pulling loose.

The pumprod forces are reduced by changing the stroke.

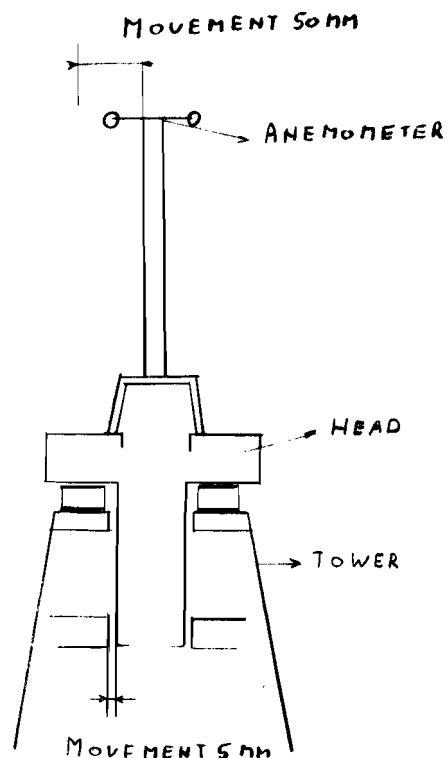
Fig. 22

The wind direction meter has broken. The cause is probably the play of the bottom head pipe bearing. The measuring mast is making a large movement (see drawing).

26.04.1984 The play in the bottom head pipe bearing is reduced by spacing shims.

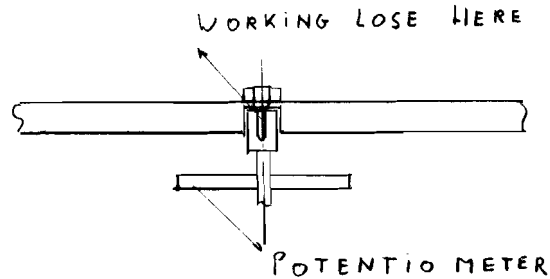
Fig. 26

14.06.1984 The wind direction meter gives wrong information.
Upon inspection it appears that the wind vane is working loose. The cause probably being the play in the under tower pipe bearing.

After mounting everything works o.k..

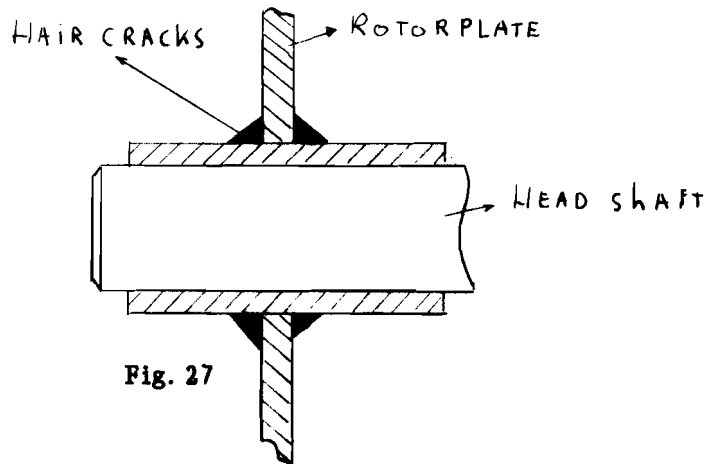
Fig. 27

12.07.1984 A general inspection reveals that there are hair cracks in the rotor plate.

19.07.1984 The hair cracks in the rotor plate are the same size as on 12.07.1984.
The water measuring unit is replaced by an other type.

30.08.1984 The windmill is running unloaded. The ditch is filled with sand and replaced by a water vessel.
The hair cracks in the rotor plate are larger as on 16.08.1984 (about half the diameter) of the rotor plate tube.

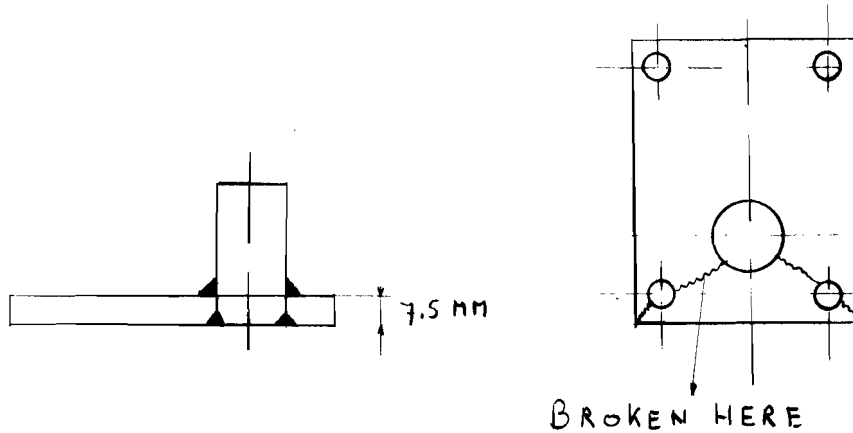
Fig. 29

- 13.09.1984 Hair cracks are the same size as on 30.8.1984.
The pump is running dry. The cause is not clear: all the fittings are tight.
The yawing speed counter gives unclear information, probably a broken signal cable.
- 20.09.1984 The crank pin is broken and the windmill is stopped. Upon inspection it appears that the crank pin plate is 7 ½ mm thick. It should be 10 mm, according to the drawings.

04.10.1984 Crank pin repaired and stroke is adjusted to 150 mm. Crank pin has new bearings. The old ones were worn; the cause is not clear.

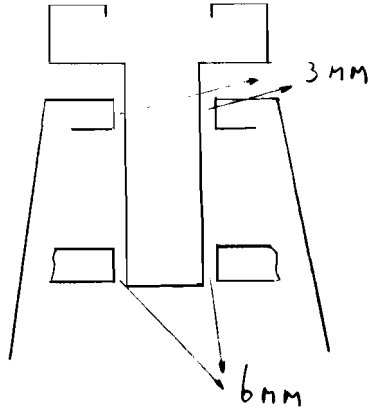
Fig. 31

- A. Head pipe bearings ± 6 mm bottom head pipe bearing ± 3 mm top head pipe bearing.

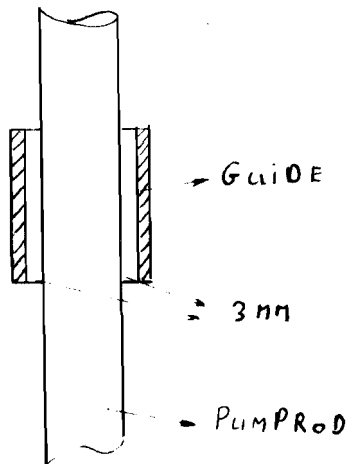
Fig. 32

- B. The pumprod guides have ± 3 mm play.

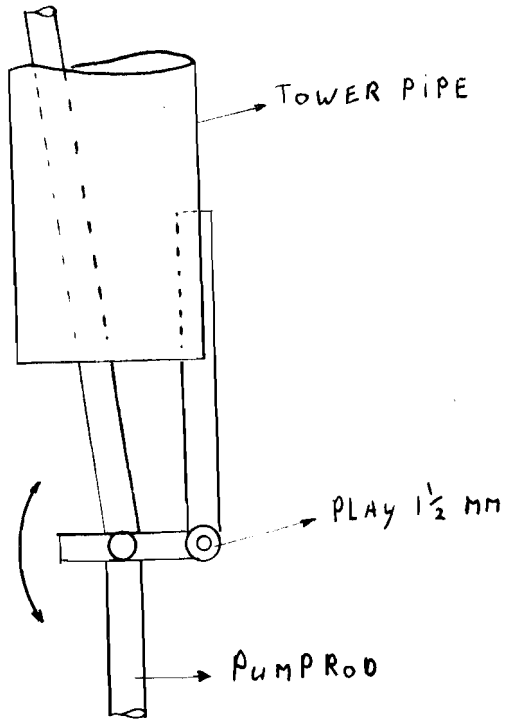
Fig. 33

C. The swing arm hinge has a play of $1\frac{1}{2}$ mm.

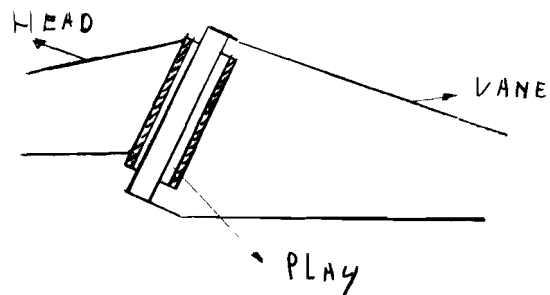
Fig. 34

D. The main vane bearing has a play of a few mm.

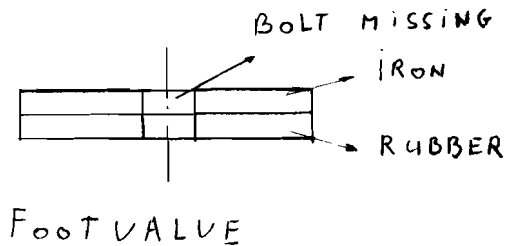
Fig. 37

28.11.1984 After dismantling the pump appears to be the cause of the priming necessity.
The bolt in the footvalve has gone so there is a hole of 9 mm. So the foot valve does not open when the windmill is running.

After repairing and mounting, the pump is working o.k..
Mounted a new wind direction meter.

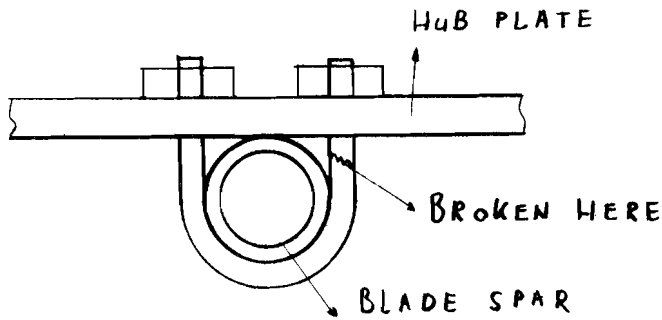
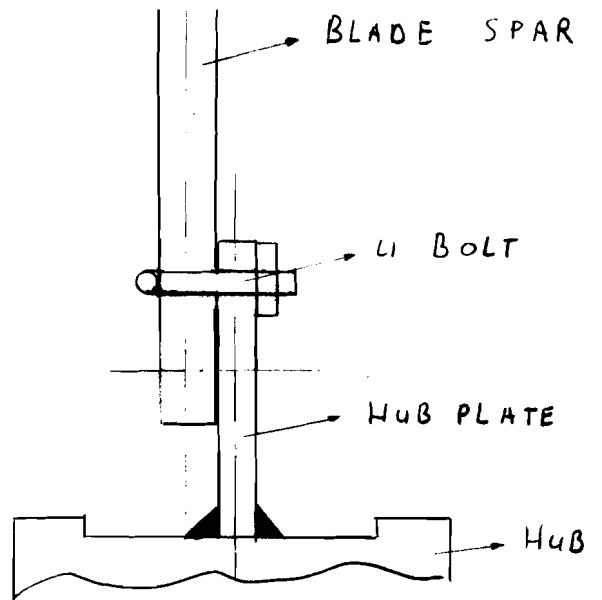
Fig. 38

02.01.1985 There is a rotor blade partly broken due to a broken U bolt.
One of the rotor blades is stuck in the tower.
