# Assessment of chemo-mechanical degradation of concrete sewer pipes through an integrated experimental approach

Luimes, R. A., Scheperboer, I. C., Suiker, A. S. J., Bosco, E., & Clemens, F. H. L. R. (2023). Assessment of chemo-mechanical degradation of concrete sewer pipes through an integrated experimental approach. *Engineering Structures*, 293, Article 116590. <https://doi.org/10.1016/j.engstruct.2023.116590>

The chemo-mechanical degradation of unreinforced concrete sewer pipes applied in domestic service locations is assessed through a systematic, integrated experimental approach, considering 18 new and 35 used sewer pipes. The characteristics and environmental conditions of the sewer pipes are reported, and data obtained from surface condition classification, residual alkalinity tests and XRD analyses are combined to identify the type and degree of chemical attack of the used sewer pipes. Concrete material properties are determined by material tests on sewer pipe samples, providing quantitative insight into the age dependency of the Young's modulus, compressive strength, tensile strength and mode I toughness. All relatively old pipes (installed in the 1920s and 1950s) show

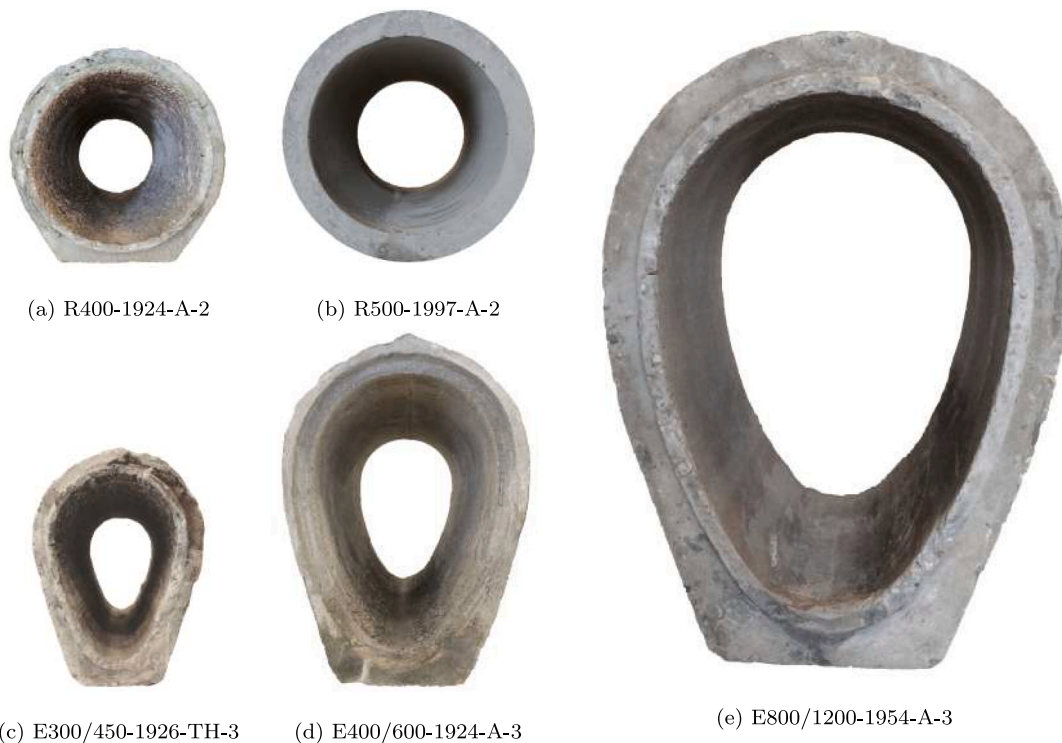
**Fig. 1.** A selection of unreinforced, used concrete sewer pipe specimens considered in the experimental program. Different surface conditions can be identified at the inner surface of the sewer pipes.

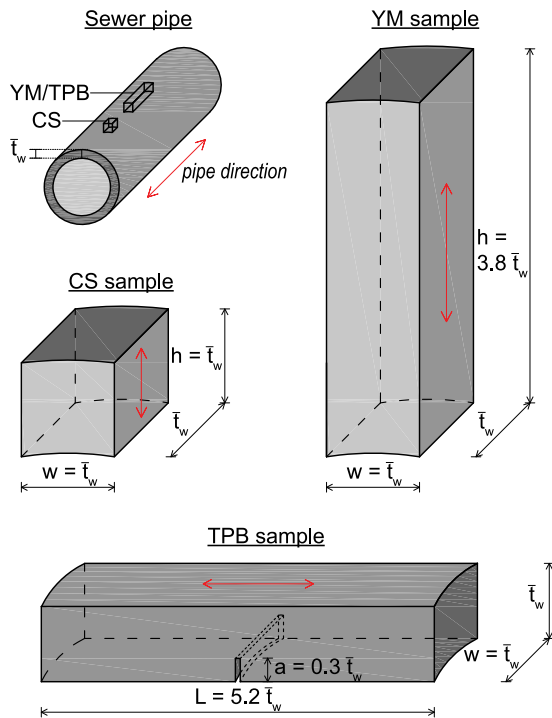
**Fig. 4.** Samples used in the uniaxial compression tests to obtain the compressive strength (CS sample) and Young's modulus (YM sample), and the notched beam sample used for determining the fracture strength and toughness in the three-point bending tests (TPB sample). The sample dimensions (beam length  $L$ , beam width  $w$ , beam height  $h$ , and notch length  $a$  are expressed in terms of the average wall thickness  $\bar{t}_w$  of each sewer pipe type, see Table 1 for an overview of the specific values. The notch thickness is equal to 4 mm (not indicated in the figure). The longitudinal direction of the sewer pipe is indicated by a red arrow in the schematic representations of the pipe and test samples. (For interpretation of the references to colour in this figure legend, the reader is referred to the web version of this article.)

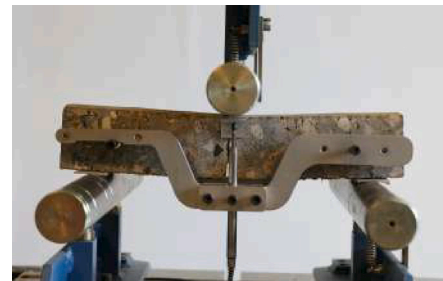
**Fig. 6.** Experimental set-up of the three-point bending test for determining the concrete tensile strength and mode I toughness. The notched specimen is equipped with an aluminum frame and an LVDT at the front and back sides of the specimen to measure at the point of load application the relative vertical displacement between the top and the centre of the beam.

calibration of the concrete tensile strength and mode I toughness. The experimental set-up of the three-point bending test is shown in Fig. 6, and consists of an Instron 5985 loading machine with a capacity of 250 kN. The notched beam specimen was simply supported across a span width of  $4.2 \bar{t}_w$ , with  $\bar{t}_w$  the average wall thickness, whereby the supports consisted of thin cardboard on top of a solid steel cylinder. At the mid-span of the sample, the load was quasi-statically applied in a displacement controlled fashion, at an initial rate of  $0.01 \mu\text{m/s}$ . During the macroscopic failure phase of the specimen, the loading rate was increased in a controlled fashion to keep the total test duration reasonable, i.e., between one and two hours. A steel cylinder was used for adequately transferring the load to the specimen. The vertical displacement at the point of load application was measured at the front and back sides of the specimen by Solartron SM3 LVDTs. The displacement transducers were attached onto the surface of the notched beam by means of an aluminium frame and an L-shaped profile, from which the relative displacement between the top and the half height of the beam could be measured, see Fig. 6. The measured load–displacement responses of the samples of each sewer pipe type were used to calibrate “minimum”, average and “maximum” values of the tensile strength and mode I toughness from the FEM results, as explained below.

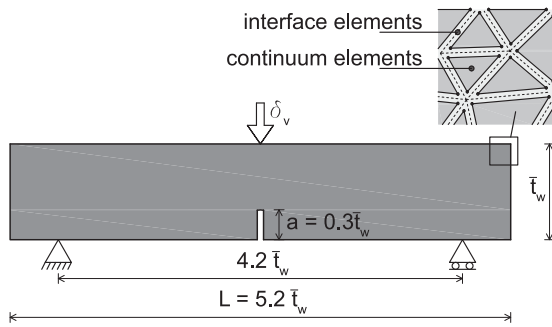
Fig. 7. Geometry and boundary conditions of the two-dimensional plane-stress model of a notched beam subjected to three-point bending. As indicated in the inset, in the FEM model the discrete fracture response is modelled by placing interface elements between adjacent continuum elements.

In the FEM analyses, the notched beam is modelled as a two-dimensional, simply-supported structure subjected to plane-stress conditions, as shown in Fig. 7. The geometry of the beam model is discretized using 3-node iso-parametric plane-stress continuum elements with a 1-point Gaussian quadrature. The discrete fracture response is

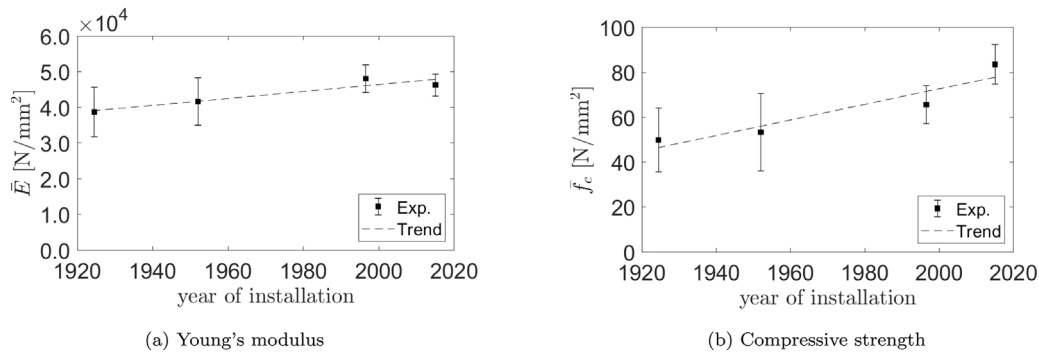
**Fig. 11.** Concrete material properties versus the year of installation of the corresponding group of sewer pipes. (a) Average Young's modulus  $\bar{E}$ , and (b) average compressive strength  $\bar{f}_c$ . The black solid squares indicate the average experimental values, with the error bars representing one time the standard deviation of the measurement results. The dashed line represents the linear trend obtained after fitting the average experimental values.
