Copper-Rubber Interface Delamination in Stretchable Electronics

J. Neggers^{1,a}, J.P.M. Hoefnagels¹, P.H.M. Timmermans², and M.G.D. Geers¹

The goal of this project is to characterize interface delamination of the copper rubber interface by means of *in-situ* Environmental SEM analysis of the delamination front during 90° Peel tests.

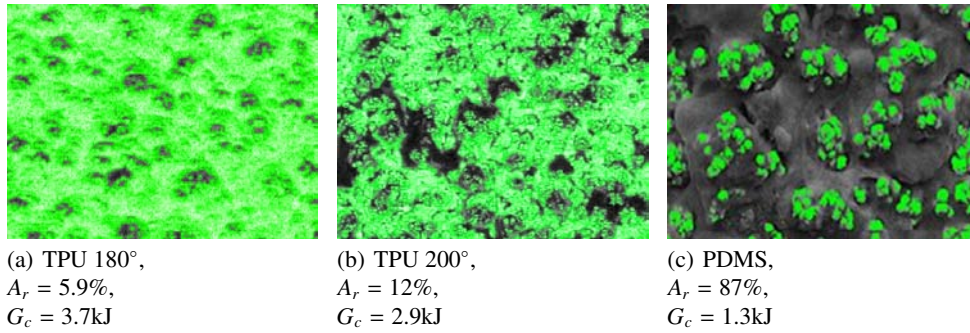
Fig. 1: Analysis of ESEM images of the copper surface after peeling, rubber is shown in black and copper in green. With A_r the rubber fraction and G_c the Work of Separation.

From a ESEM analysis of the delaminated surface of the same Cu (roughness) but 2 types of TPU (TU-Berlin) and 1 PDMS (IMEC Ghent) rubber system it was found that: The amount of rubber left at the surface A_r after delamination remarkably increased with decreasing Work of Separation (Figure 1).

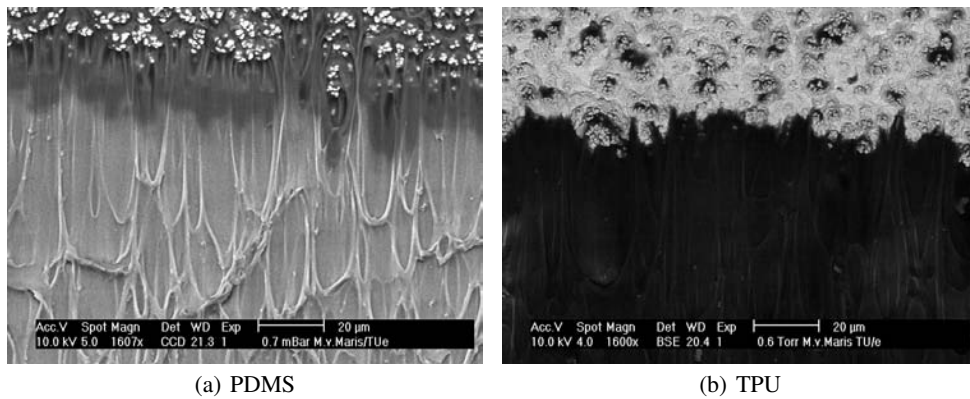
Fig. 2: *In-situ* ESEM image of a progressing delamination front of the copper rubber interface.

From *in-situ* observations of the realtime delamination tests it was found that: Interface delamination is a delicate balance between the forming, elongation and rupture of fibrils and interface delamination (Figure 2).
