Fatigue of threaded rods in cable anchorages due to vortex shedding

Snijder, H. H., & Maljaars, J. (2013). Fatigue of threaded rods in cable anchorages due to vortex shedding. In *36th IABSE Symposium, 24-27 September 2013, Kolkata* (pp. 1-8). International Association for Bridge and Structural Engineering.

Fatigue of Threaded Rods in Cable Anchorages due to Vortex Shedding

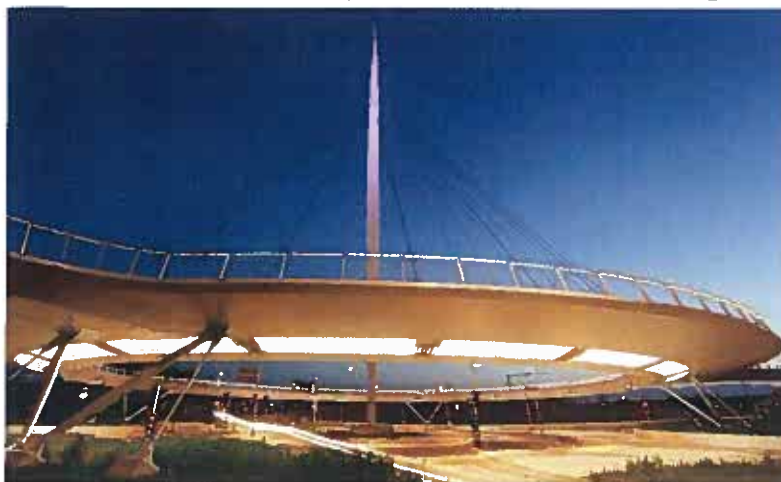
Fig. 1: Cable-stayed bicycle roundabout flyover
'Hovenring' (photo courtesy of Municipality of Eindhoven)

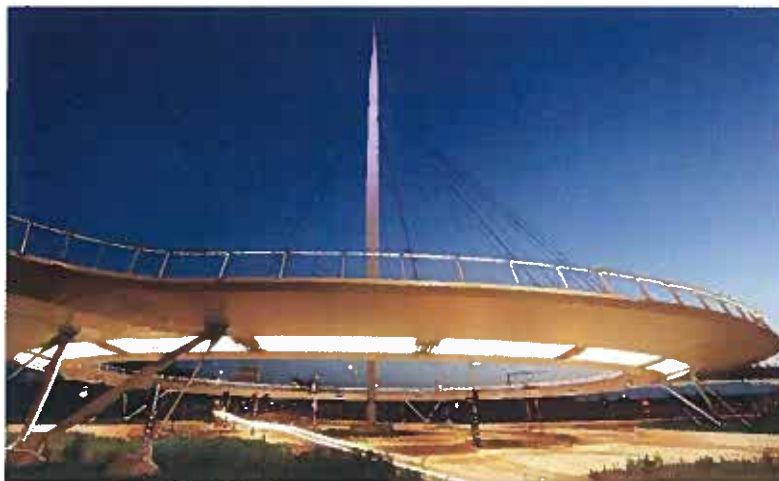
Fig. 1: Cable-stayed bicycle roundabout flyover 'Hovenring' (photo courtesy of Municipality of Eindhoven)

Based on an example of a real structure, it is shown that vortex shedding of stay cables can result in an extremely short design fatigue life. The 'Hovenring', built in the years 2011-2012 in Eindhoven, The Netherlands, is a suspended cable-stayed bicycle roundabout flyover (Fig. 1) with a central 70 meter high steel pylon carrying a 72 meter diameter circular bridge deck through 24 stay-cables. The bridge deck is virtually floating over a motorway junction. It separates bicycles from cars, thus offering a safe passage to cyclists. It is a landmark structure and a signature bridge especially developed for this location.

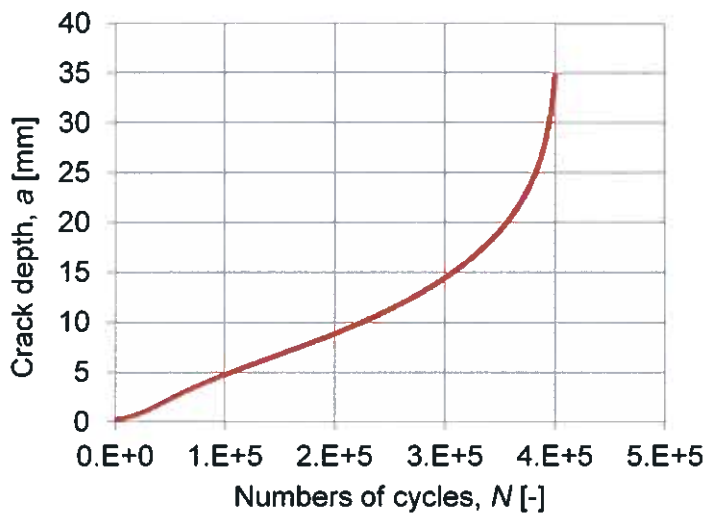
Fig. 6: Fatigue crack growth in M72 threaded rod based on stress range histogram

Fig. 6 shows the fatigue crack growth in the M72 threaded rod using the stress range histogram, assuming that the different stress ranges appear in random order. Sequence effects are not modelled. Fig. 6 shows that the number of load cycles from the initial defect to failure is $N_R = 400000$ cycles. Then, the fatigue damage D can be determined by dividing the number of occurring load cycles $\sum n$ (Table 1, bottom of column #2) by the number of load cycles to failure: $D = 4,67 \cdot 10^7 / 400000 = 117 \gg 1,0$. The design fatigue life can then be calculated as follows: $1/117 \cdot 23 \text{ days} \cdot 24 \text{ hours/day} = 4,7 \text{ hours.}$
