### Improving waste management at Toyota Motor Manufacturing (UK)

Gubbels, B.J.

*Award date:*  
2001

Achieving Zero waste to Landfill in assembly 1 through Empowerment

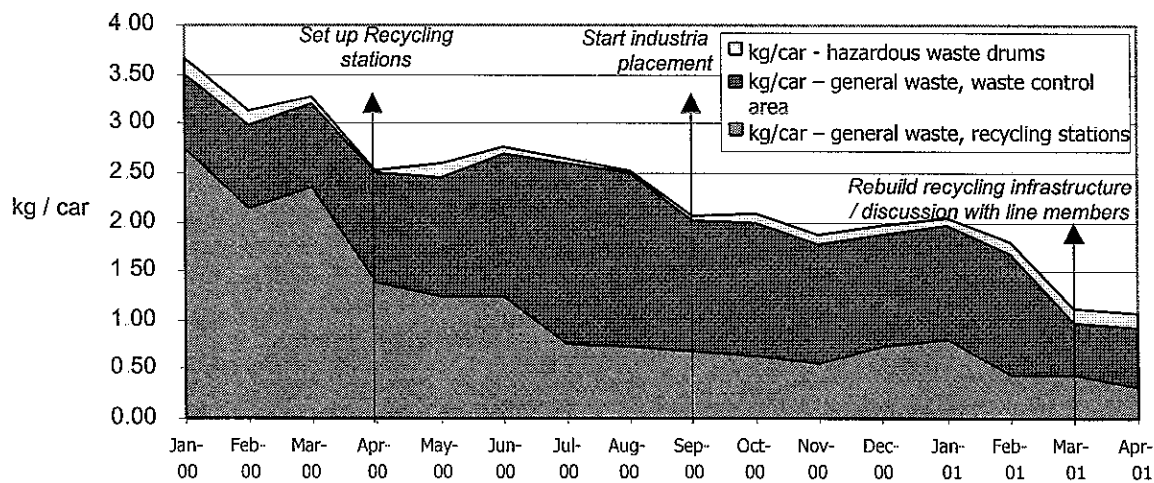
Figure 3 Waste to landfill in Assembly 1 from Jan. '00 to April '01

The total amount of waste to landfill can be broken down by distinguishing three waste sources (see figure 3). Most of the waste to landfill at the start of the project came from the waste control area. This waste stream had already been a significant part of the waste to landfill from the assembly shop before the recycling stations were set up, but had increased after April 2000.
