# Survey of the experiences in particular with the prototype of the CWD 2000 windmill at the Technical University Eindhoven from May 1983 until December 1985

Survey of the experiences in  
particular with the prototype of the  
CWD 2000 windmill at the  
Technical University Eindhoven  
From May 1983 until December 1985

Ad v.d. NAT

R 810 D

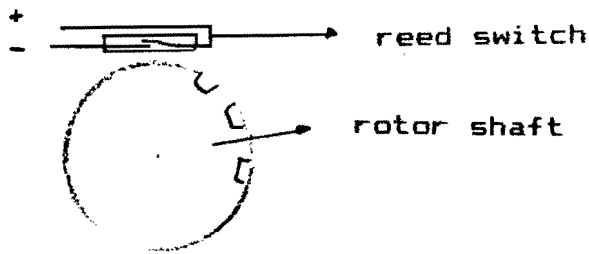
Revolution counter was mounted on the rotor shaft.  
See drawing.

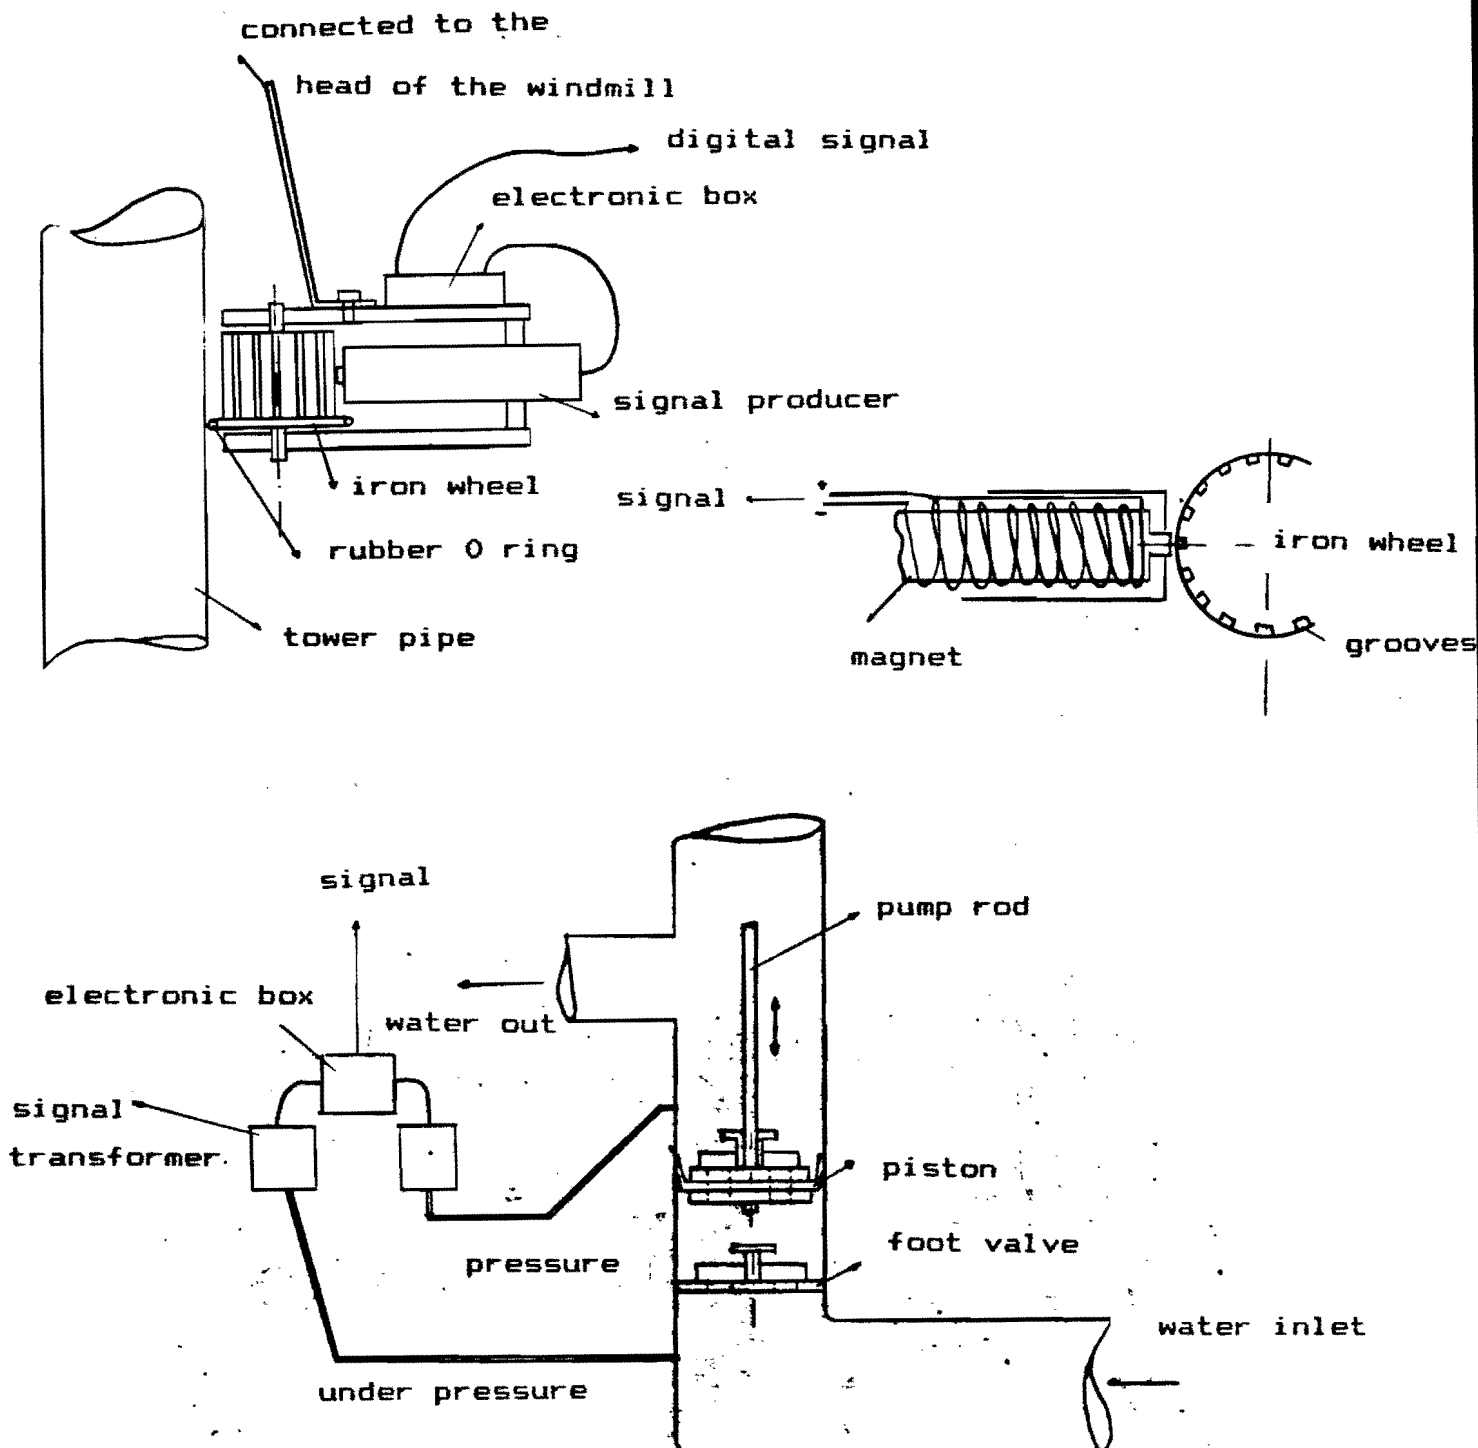
A new cable was mounted from the head of the windmill to the central box on the ground.  
 Because the windmill had turned several times around his axis the cable was broken.

A yawing speed counter was mounted together with a pressure pick up for measurements of the dynamic pressure in the pump.

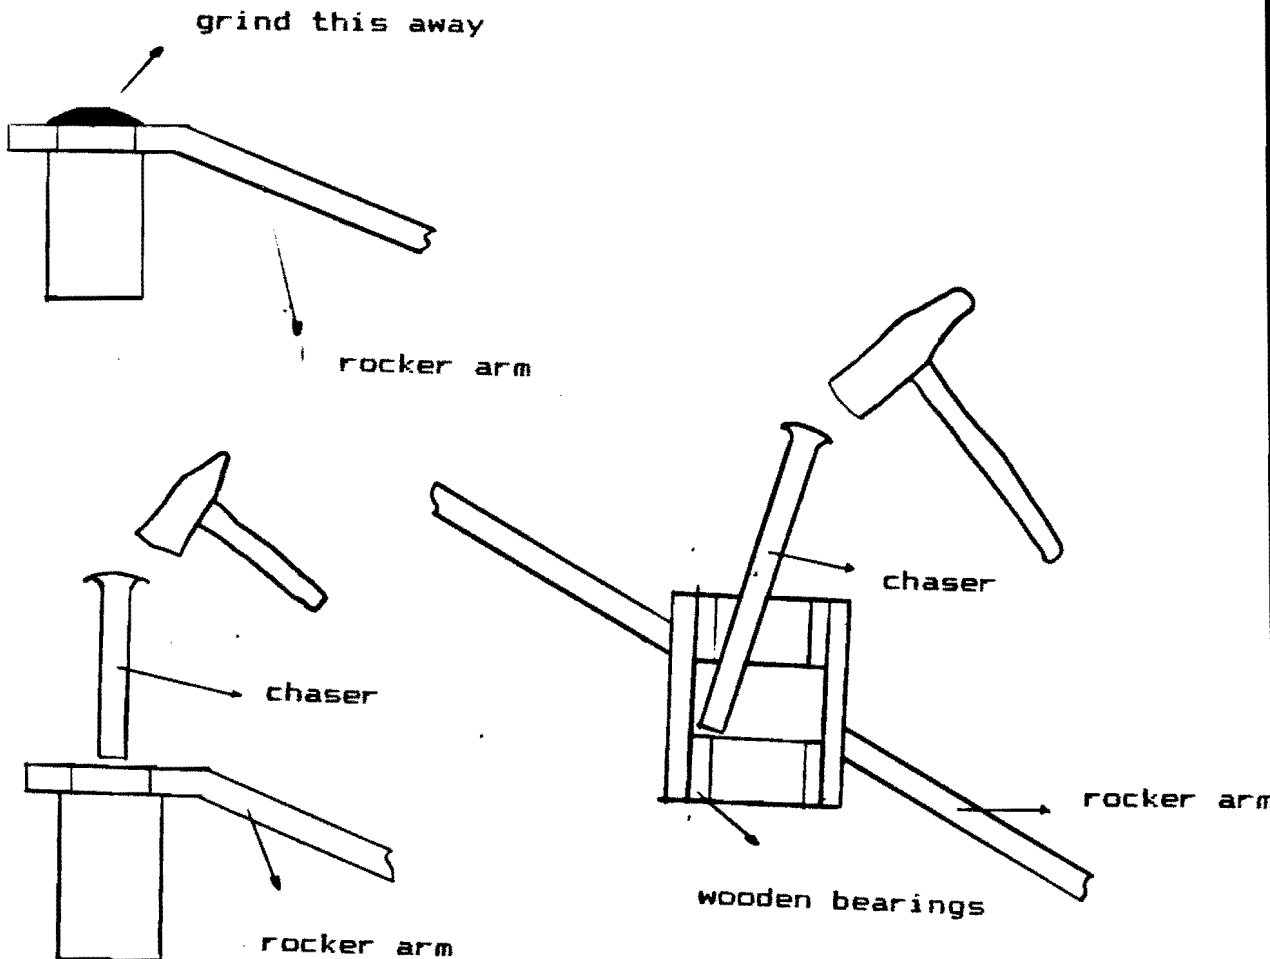
- a. The wooden bearings were complete worn out.  
 The crank pins of the rocker arm are also worn out.  
 The cause being defective lubrication by ineffective grease cups.
- b. The rotor shaft bearings are worn out.  
 The cause being defective lubrication by no grease in the bearing house.

- a. The bearings of the rocker arm were worn out.
- b. The ball bearings of the rotor shaft were worn out.
- c. The windmill needed painting.

- a. Manufacturing of new crank pins for rocker arm and head frame.
- b. Manufacturing of new wooden bearings for rocker arm and pump rod.
- c. Manufacturing of new rotor shaft.
- d. Removing of old crank pins from rocker arm head frame.

- e. Removing of wooden bearings.
- f. Grinding of the windmill and spraying with correless paint, and Sikkens car paint (white).
- g. Welding of new crank pins in to the rocker arm with special care to the parallism of the crank pins.
- h. Pressing of new wooden bearings in rocker arm and pump rod, and making of bearings at the right size.
- i. Mounting of the head frame and the bearing houses and filling of them with grease.
- j. Manufacturing of new packings for the pump.
- k. - Mounting of the pump under the windmill.  
- Mounting of the head frame on the windmill.  
- Mounting of the rotor.

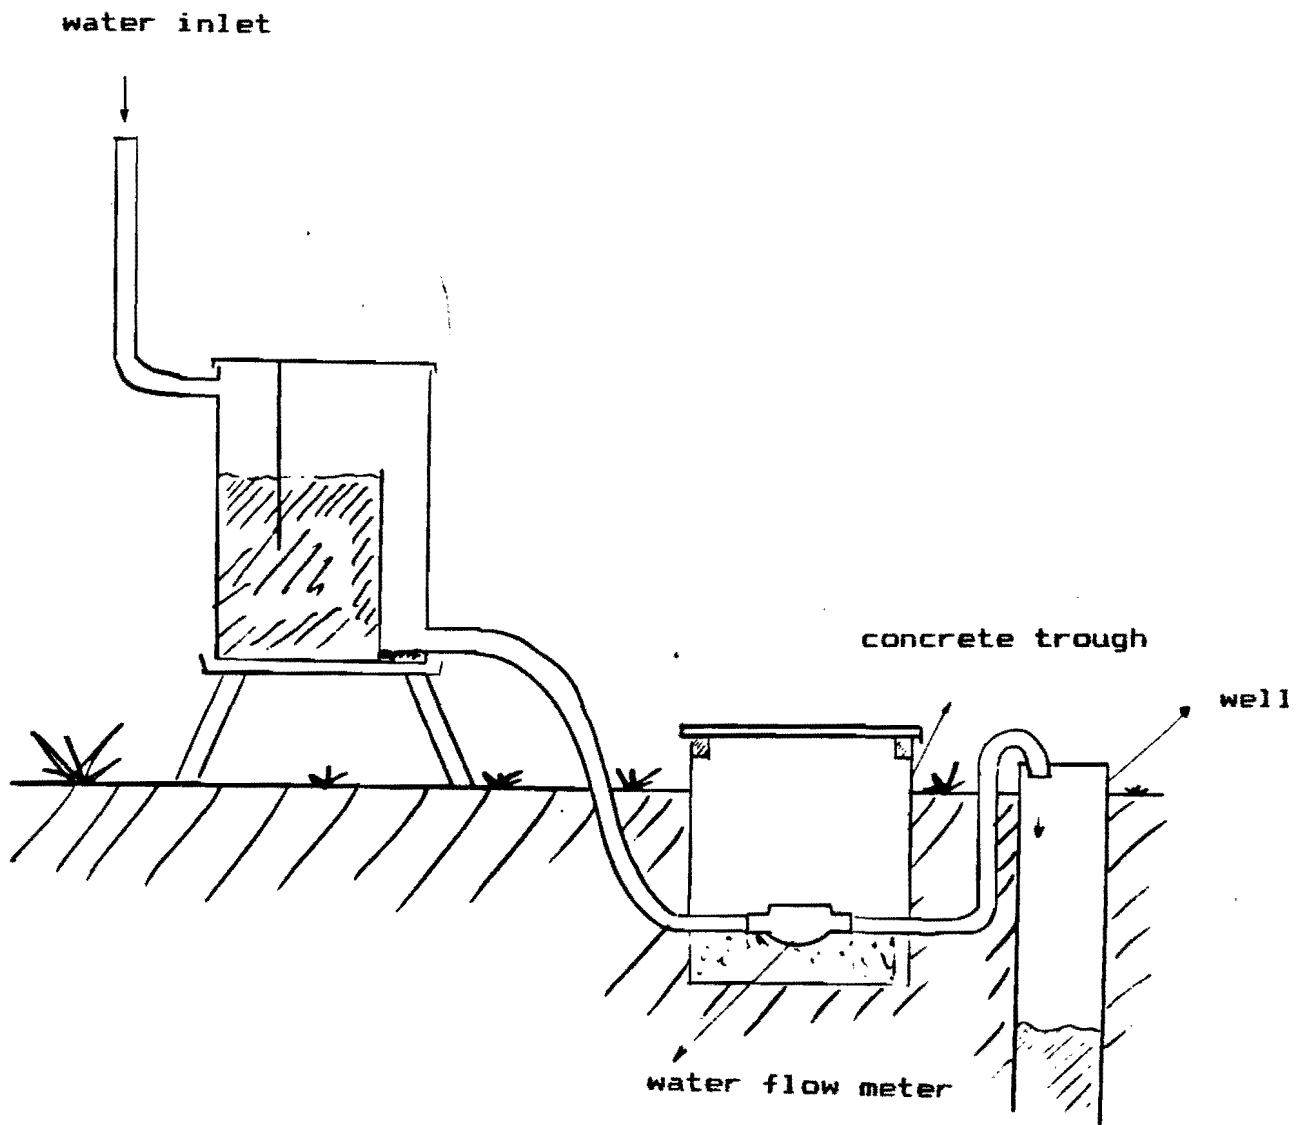
We have changed the water measuring system to reduce the time between delivery of water from the windmill and measuring of the water.

- Reaction time between delivery of water from the windmill to measuring of the water is now  $\pm$  30 a 45 sec. (There is more pressure over the water meter.)
- Water flow meter within better reach.

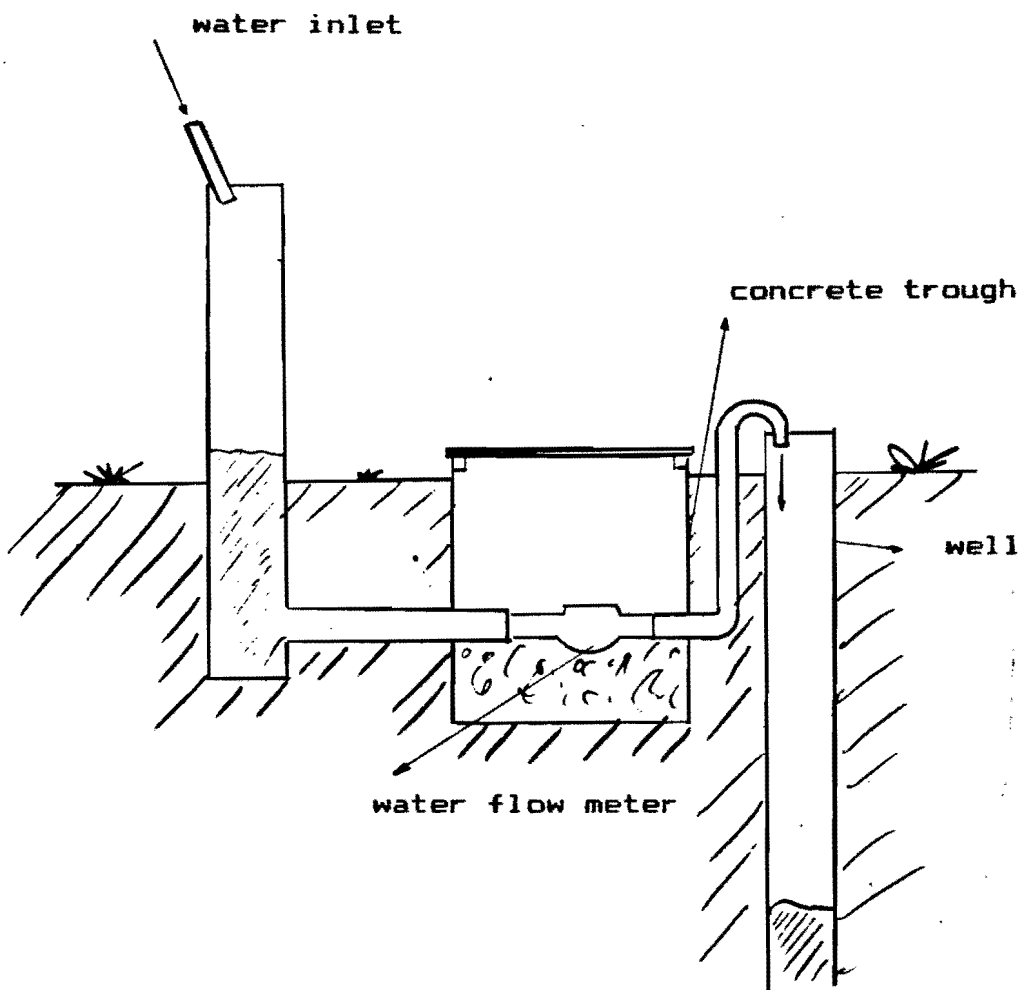
We have changed the water measuring system.  
See drawing.

- The time between pumping water and measuring water is reduced. Time is now  $\pm 5$  a 10 sec. (more pressure over the water meter).
- The total amount of water in the system is far less than the other system.

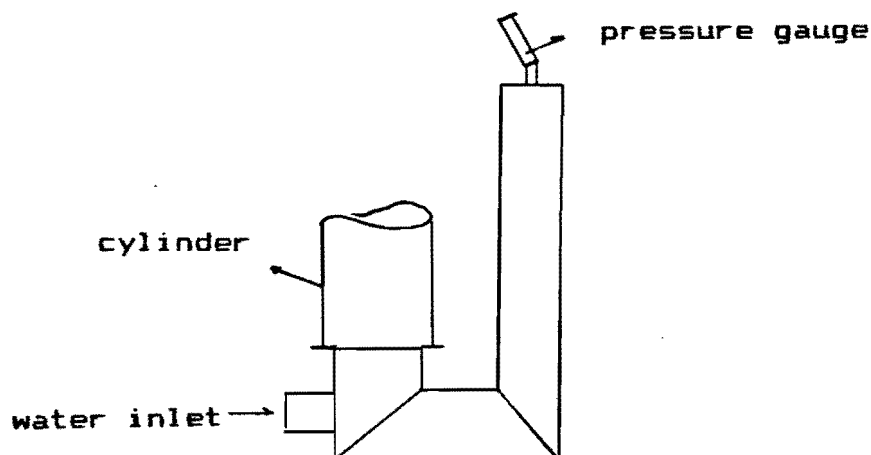
A pressure gauge on top of the suction air chamber was installed to obtain the pressure and under pressure in the air chamber.

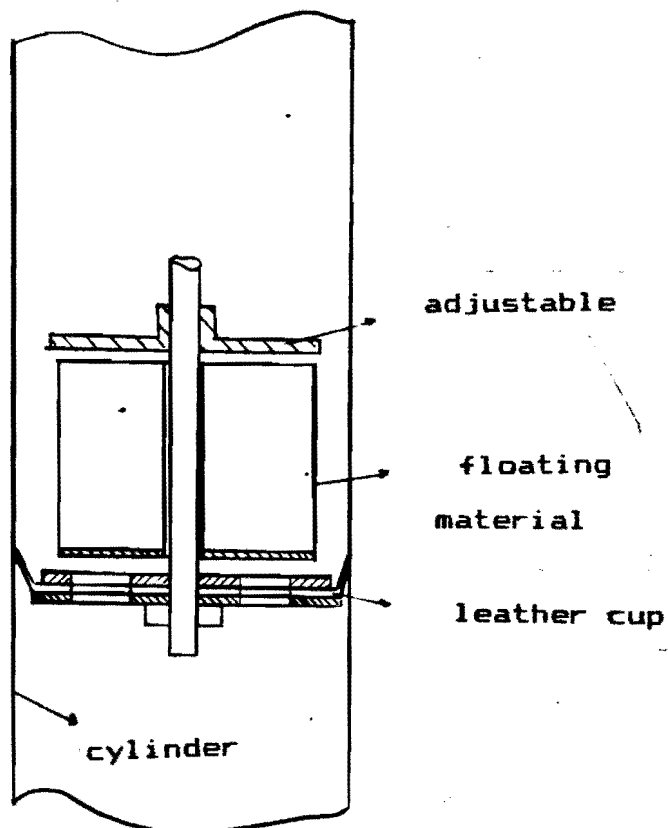
The measurements were stopped for a period.  
The pump was dismantled to remove the floating valve which was  
needed for measurements in the test rig at the laboratory of the  
CWD.

The valve floats when the windmill is standing still.  
There is no resistance in the pump when the windmill is starting.  
At sufficient rpm of the rotor the water stream closes the valve  
by the under pressure caused by the water acceleration through  
the slit between piston valve and piston.  
The under pressure moves the floating valve down to the piston.  
Then the windmill starts to deliver water.

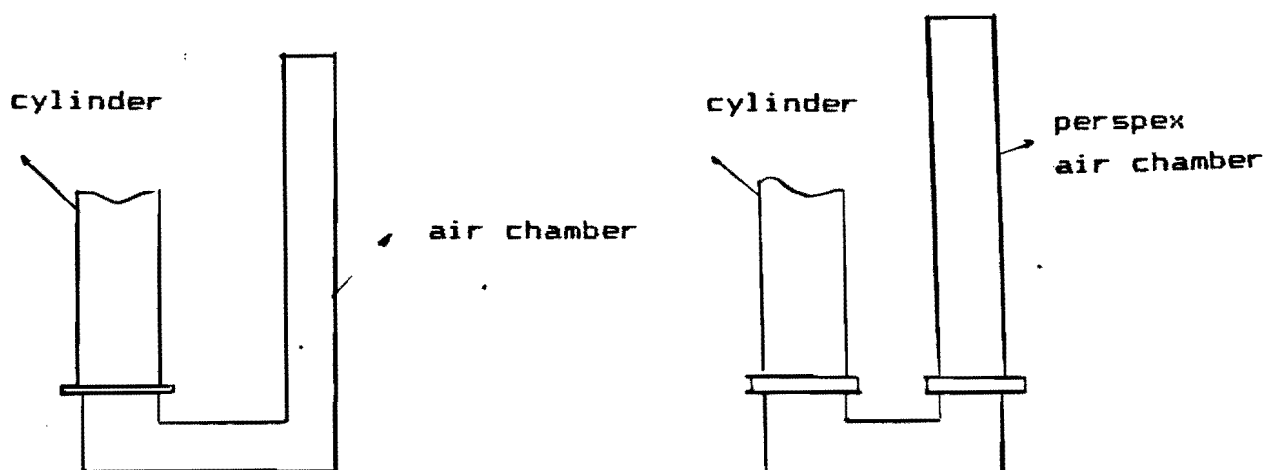
The suction air chamber is changed by a perspex one so we can see what is going on in the air chamber.

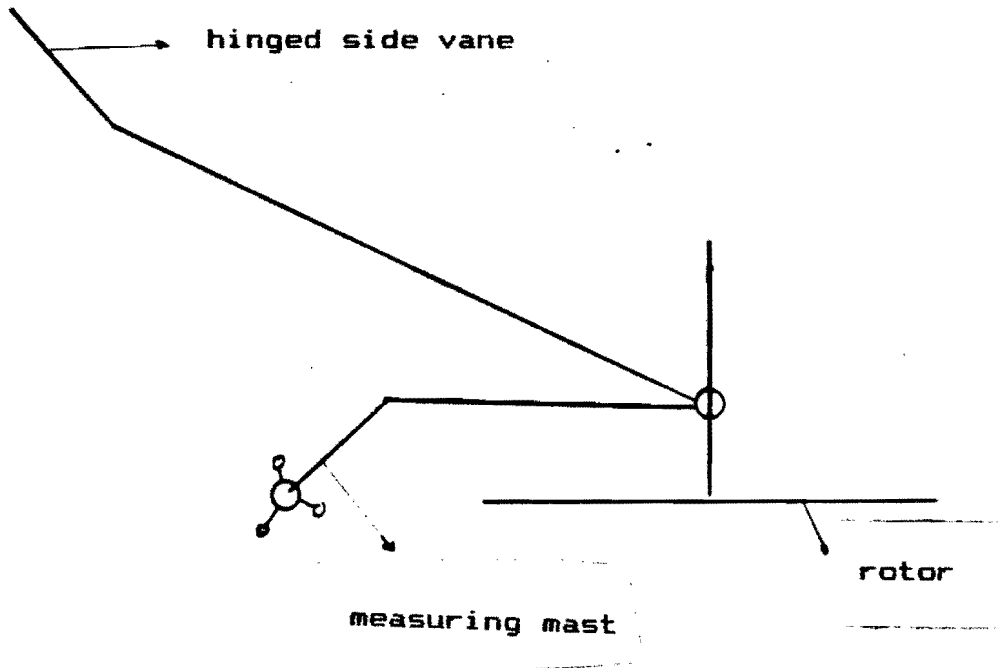
We have placed a measuring mast on the head of the windmill to measure:

- wind speed
- wind direction.
