SURVEY OF THE EXPERIENCES ON THE TESTFIELD
AT THE EINDHOVEN UNIVERSITY OF TECHNOLOGY
IN PARTICULAR FOR THE WEU 1-3 WINDMILL
from April 1983 until May 1985

Ad v.d. Nat

July 1985

R-742-D

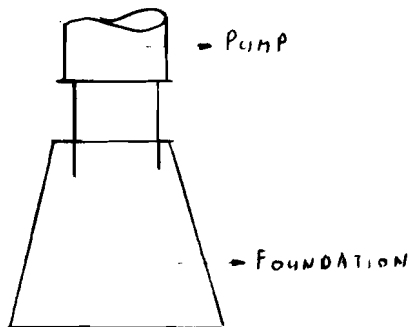
Fig. 4

A spare delivery air chamber is installed, this one is o.k. The counter piston is leaking a little: about 10 cc per stroke. The pump foundation is too light so when the windmill is running it is moving up and down. The solution for this problem is to make the foundation heavier by adding 50 kg of concrete.

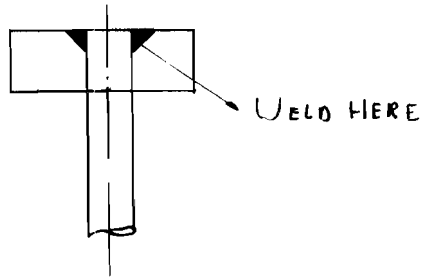
Fig. 13

06.01.1984 The swivel point of the pumprod has broken. The cause is too high a pumprod force.

The cause of the high forces in the pumprod is among others a play of ± 5 mm in the swivel point, so there is a shock load on the pumprod.

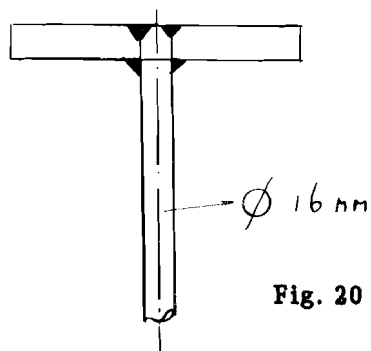
Fig. 20

01.03.1984 The pumprod has broken again at the flattened part.

It is decided to make this part of the pumprod stronger.
The 1" flattened tube is replaced by a $\phi 16 \text{ mm}$ rod.

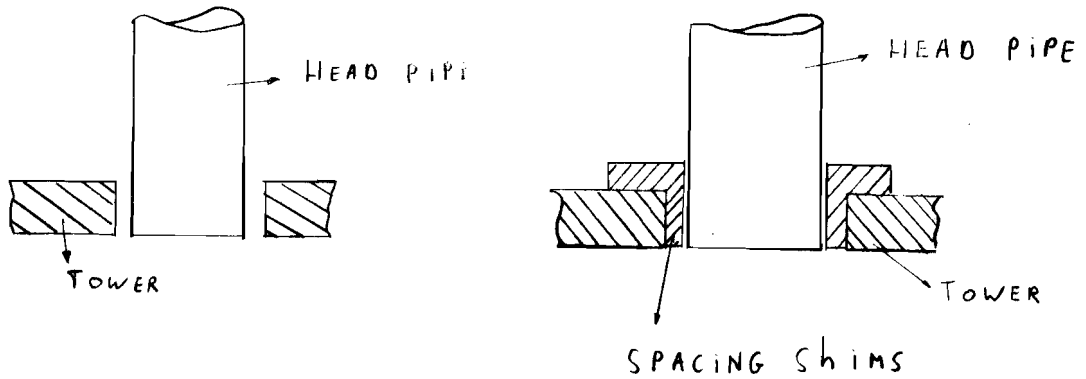
Fig. 23

The wind direction meter has broken. The cause is probably the play of the bottom head pipe bearing. The measuring mast is making a large movement (see drawing).

26.04.1984 The play in the bottom head pipe bearing is reduced by spacing shims.

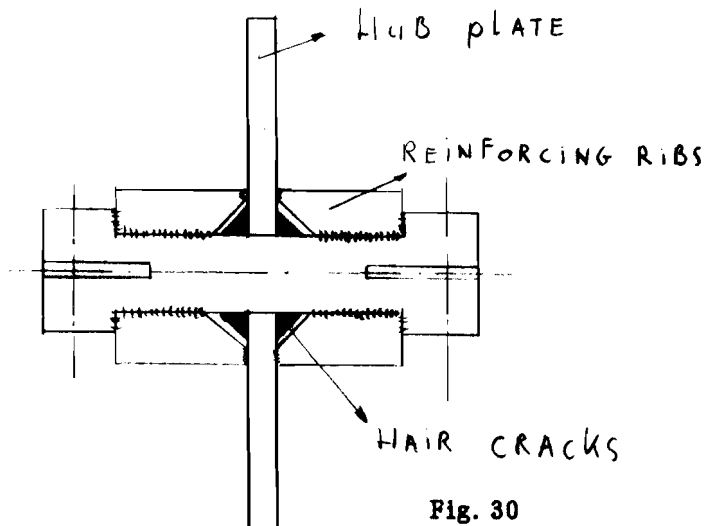
30.08.1984 The windmill is running unloaded. The ditch is filled with sand and replaced by a water vessel.
The hair cracks in the rotor plate are larger as on 16.08.1984 (about half the diameter) of the rotor plate tube.

- 27.09.1984 Reinforcing ribs are welded to the hub plate.
