# Hygro thermal simulation to predict the risk of frost damage in masonry : effects of climate change

6th International Building Physics Conference, IBPC 2015

## Hygro Thermal Simulation to Predict the Risk of Frost Damage in Masonry; Effects of Climate Change

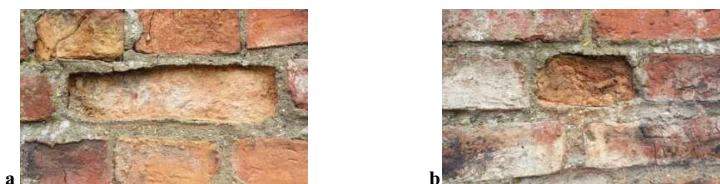
Fig. 1. (a) and (b) examples of frost damage.

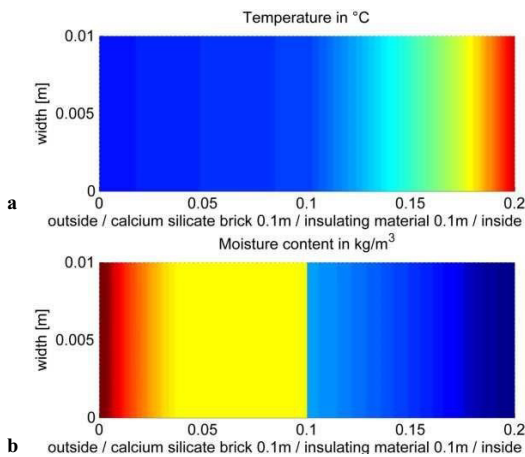
Fig. 2. Temperatures (a) and moisture contents (b) over the cross section of the construction for one time of January 22<sup>nd</sup> in 1979.

Results are discussed with reference to case study 1 for the climate data of the KNMI for January and February of 1979. Calculated temperatures ( $\theta$ ) and moisture contents ( $w$ ) over the cross section of the construction are presented for one time at January 22<sup>nd</sup> in 1979 in figure 2. At the outer surface of the construction the temperature is less than 0°C, and at the same time the moisture content is higher than capillary saturation ( $w_{cap}$ ). Under these conditions: ( $\theta < 0^\circ\text{C}$ ) and ( $w > w_{cap}$ ), there is a risk of frost damage in the brick of calcium silicate. Frost damage is generated mainly at the outside of the structure [16]. In figure 3, temperature ( $\theta$ ) and moisture content ( $w$ ) are presented occurring 1 mm underneath the outer surface of the construction. Eleven times there is a risk of frost damage: the temperature is below 0°C and simultaneously the moisture content is higher than capillary saturation. The depth of the risk of frost damage, as seen directed from the outer surface into the interior of the construction as a function of time is presented in figure 4a. The depth range of the risk of frost damage is usually between 3.5 and 7 mm,

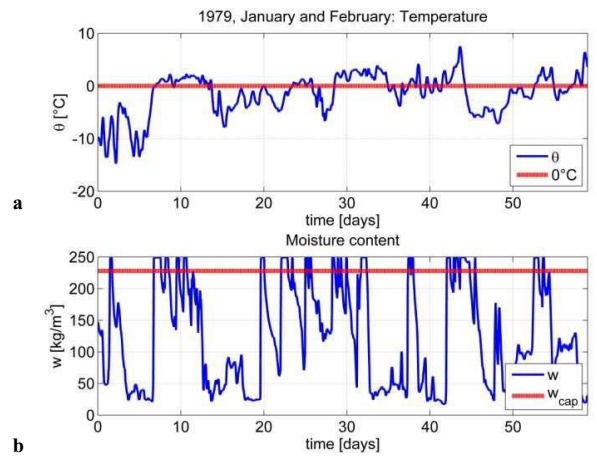
Fig. 3. Temperatures (a) and moisture content (b) occurring at 1 mm underneath the outer surface of the construction for the months of January and February of 1979.
