Copper-rubber interface delamination in stretchable electronics

Copper-Rubber Interface Delamination in Stretchable Electronics

The goal of this project is to characterize interface delamination of the copper rubber interface by means of *in-situ* Environmental SEM analysis of the delamination front during 90° Peel tests.

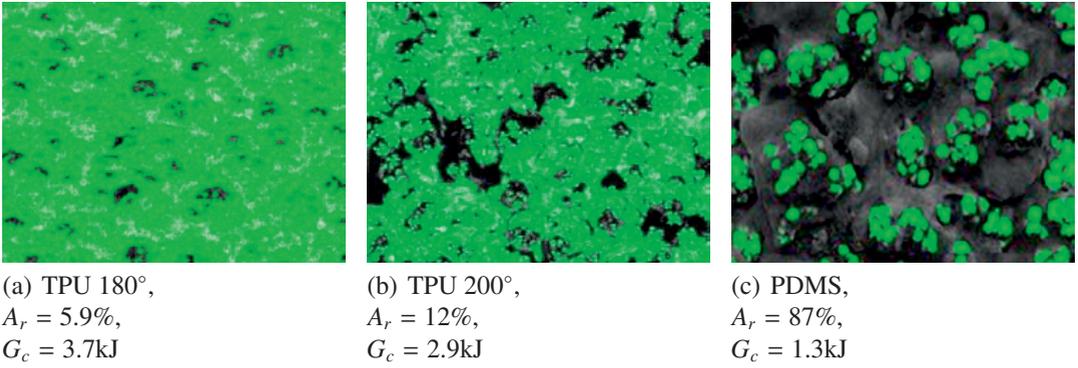
Fig. 1: Analysis of ESEM images of the copper surface after peeling, rubber is shown in black and copper in green. With A_r the rubber fraction and G_c the Work of Separation.

From a ESEM analysis of the delaminated surface of the same Cu (roughness) but 2 types of TPU (TU-Berlin) and 1 PDMS (IMEC Ghent) rubber system it was found that: The amount of rubber left at the surface A_r after delamination remarkably increased with decreasing Work of Separation (Figure 1).

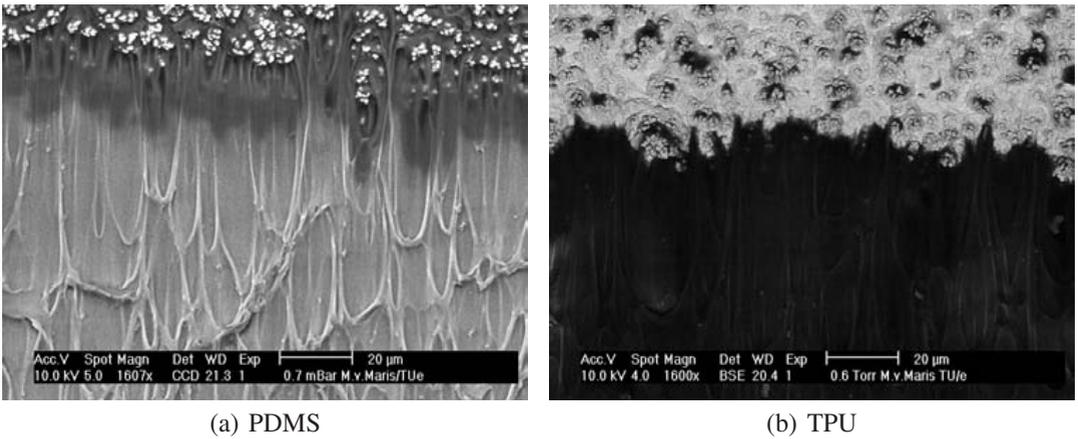
Fig. 2: *In-situ* ESEM image of a progressing delamination front of the copper rubber interface.

From *in-situ* observations of the realtime delamination tests it was found that: Interface delamination is a delicate balance between the forming, elongation and rupture of fibrils and interface delamination (Figure 2).
